# EXHIBIT C

ASAIO lournal 1998

# Comparison of the *In Vivo* Behavior of Polyvinylidene Fluoride and Polypropylene Sutures Used in Vascular Surgery

CÉLINE MARY,\* YVES MAROIS,\* MARTIN W. KING,\*† GAÉTAN LAROCHE,\* YVAN DOUVILLE,\*
LOUISETTE MARTIN,\* AND ROBERT GUIDOIN\*

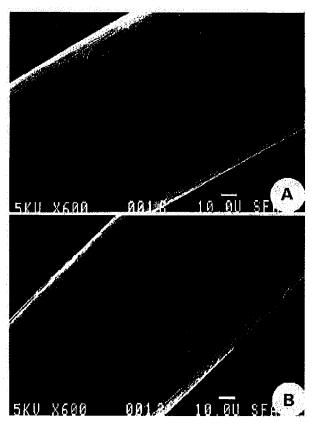
Figure 6. Scanning electron photomicrographs of retrieved and cleaned 6–0 polyvinylidene fluoride sutures showing the surface morphology after implantation for 1 (A,  $\times$ 600) and 2 (B,  $\times$ 600) years in vivo.

The reason why this cracking phenomenon was not observed with the explanted PVDF sutures after 1 year and 2 years *in vivo* is not known at this time. One possible explanation for the apparent superior biostability of the PVDF monofilaments, however, may lie in their less pronounced bicomponent skin/core structure, which is attributable to their different manufacturing history.<sup>17</sup>
